**UNITED STATES ENVIRONMENTAL PROTECTION AGENCY
SUPERFUND SITE STRATEGY RECOMMENDATION - REGION 06**

Site Name: Delta ShipyardCERCLIS ID#: LAD058475419Address: Industrial BoulevardCity/County or Parish/State/Zip Code: Houma/Terrebonne/LAReport Type, Date, and Author: SIP, June 15, 1995, ARCS**RECOMMENDATION**

**SITE INSPECTION PRIORITIZATION REPORT
AND PRESCORE PACKAGE
DELTA SHIPYARD
PHASE III
HOUMA, LOUISIANA
EPA ID NO.: LAD058475419**

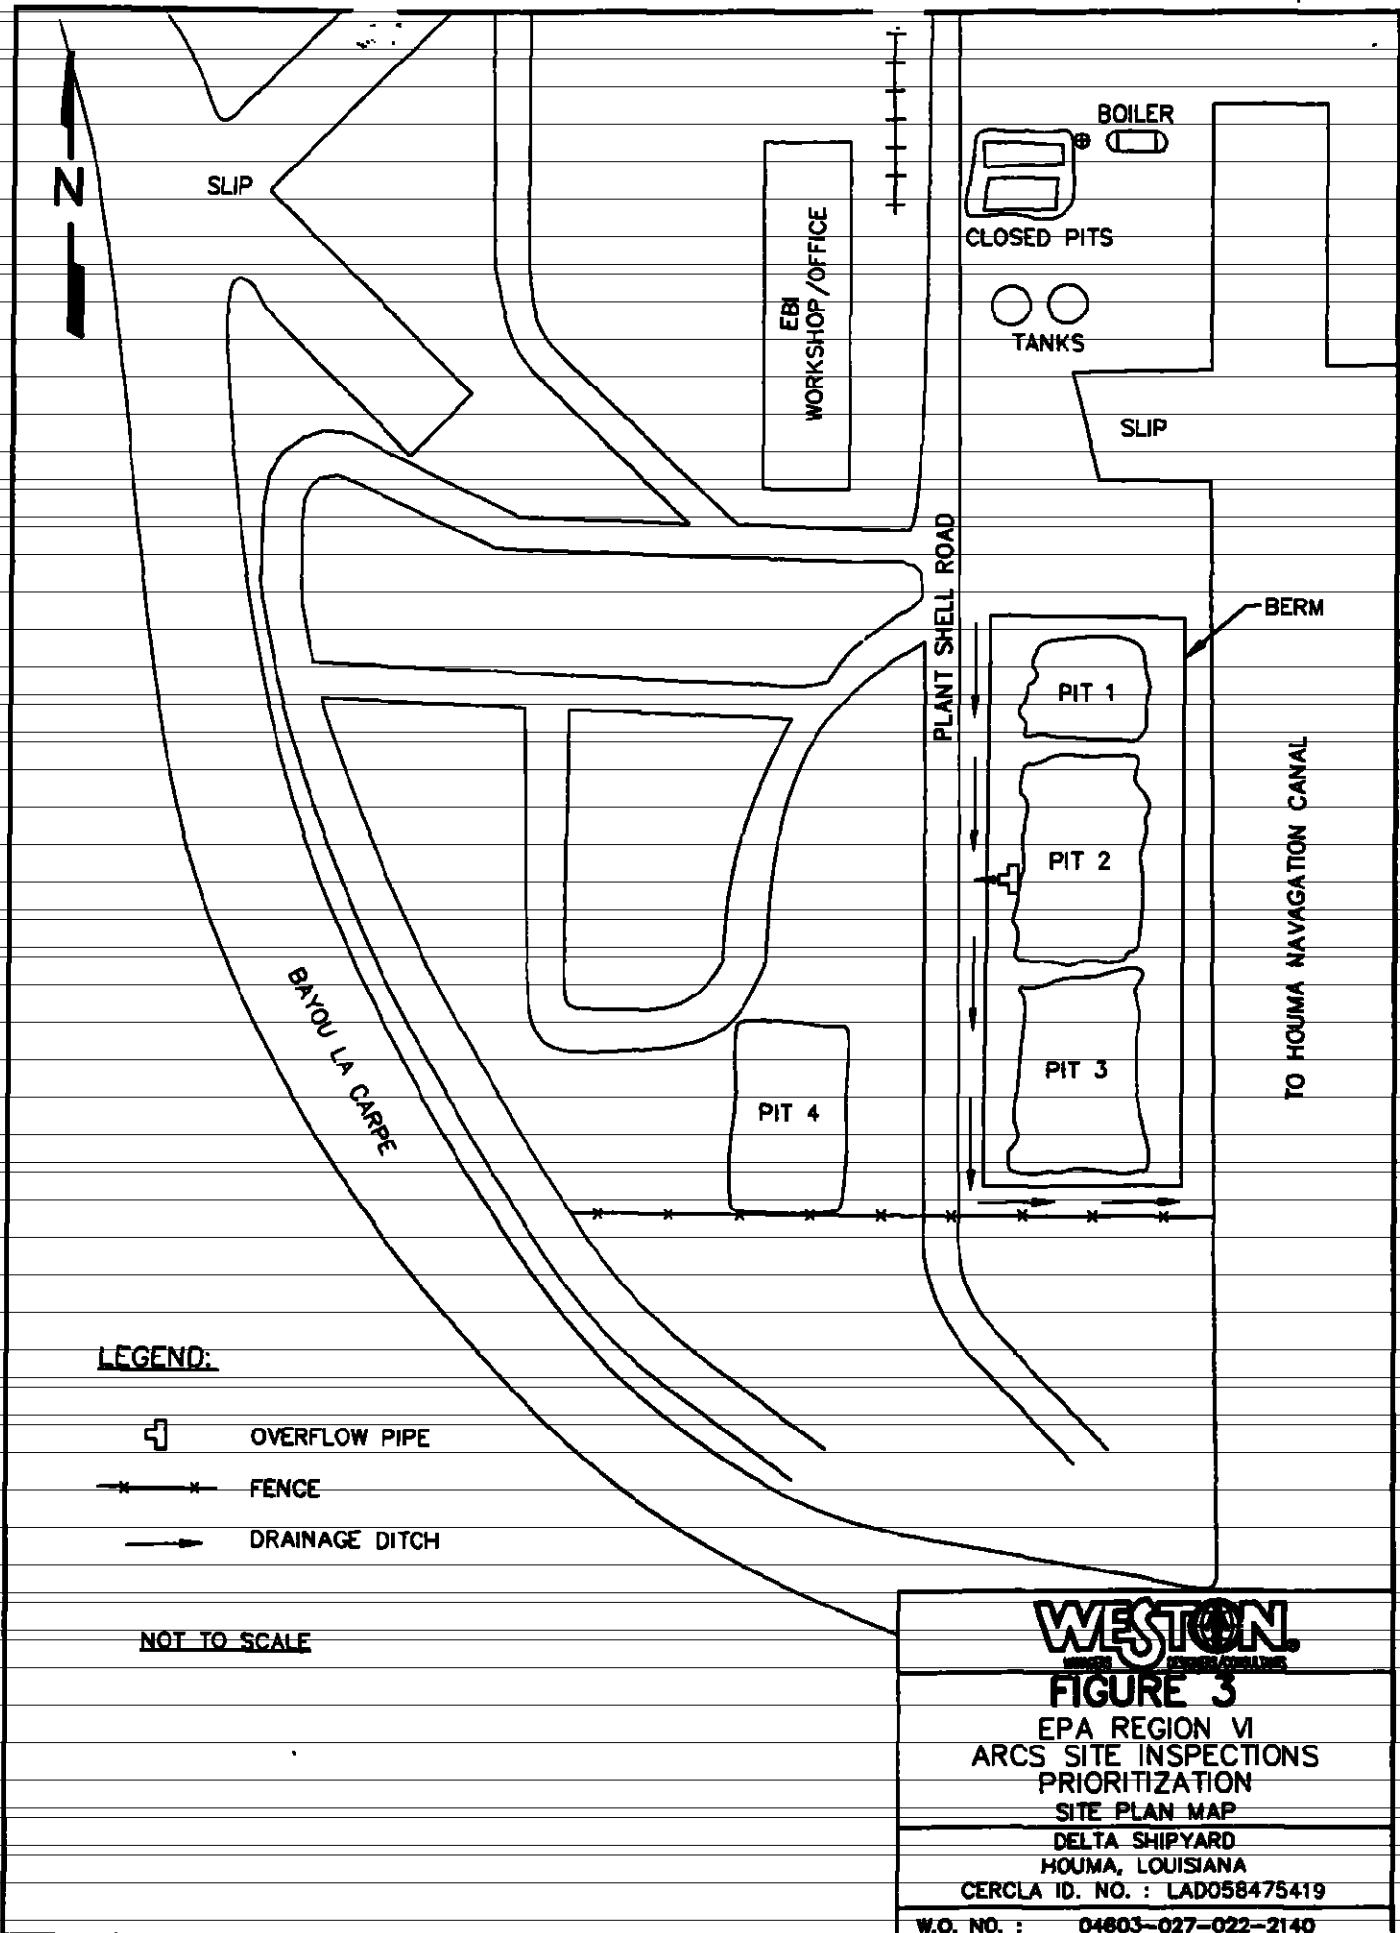
DS owned the site prior to EBI; the year operations began at the site is unknown. DS consisted of a barge gas-freeing operation and a cleaning and repairing facility for small cargo vessels, fishing vessels, and oil barges. The gas-freeing operation was required because the vessels had to be certified vapor free by the U.S. Coast Guard before repair work could commence. As part of the gas-freeing process, the vessels were steam-cleaned and the oily wastes were removed. The generated oils and wastewater were sent through a separation process after which the waste oil was recovered and sold. Wastes were stored in surface impoundments on-site. Two small waste pits, located approximately 100 feet east of the fabrication building, were sampled and closed in 1984 under the supervision of the Louisiana Department of Environment Quality (LDEQ) Hazardous Waste Division. Two monitoring wells are reportedly located around the closed pits; however, during the site reconnaissance, only one could be located. The pits were reportedly used to dispose of waste oil and oil field drilling material. A Site Plan Map is provided in Attachment 1 as Figure 3.

The DS site contains old gas-stripping equipment (i.e., storage tanks, separator, boiler) left behind from the former operation. The two closed waste oil surface impoundments are now a parking lot used by EBI employees. Four larger pits are located approximately 800 feet south of the fabrication building and are surrounded by dense vegetation. One pit is located west and the other three are located east of Plant Shell Road. According to a Wink Engineering sampling report in 1985, the pit west of the road is actually three pits in series that have been covered over with fill material. For the purposes of this Phase III report, these pits are considered one single pit. The three pits east of the road are exposed and covered with a crusty black substance. At the time of the site reconnaissance, rainwater containing an oily sheen was pooled on the surface of the pits.

Four waste source areas were identified in the file review and site reconnaissance. They consist of four pits used to store waste oils from the DS ship cleaning and repair operation. Pit 4 is actually three pits according to a Wink Engineering report; however, the pits are aligned in series, covered over, and vegetated. For purposes of the Phase III report, they are designated together as Pit 4. The other three pits (1, 2, and 3) are exposed and covered by a black crusty substance. Pits 1, 2, and 3 are elevated and surrounded by a 3- to 6-foot berm. The four pits together have an approximated surface area of 294,000 square feet. The waste characteristics of the site were assessed for the groundwater, soil, and surface water exposure pathways.

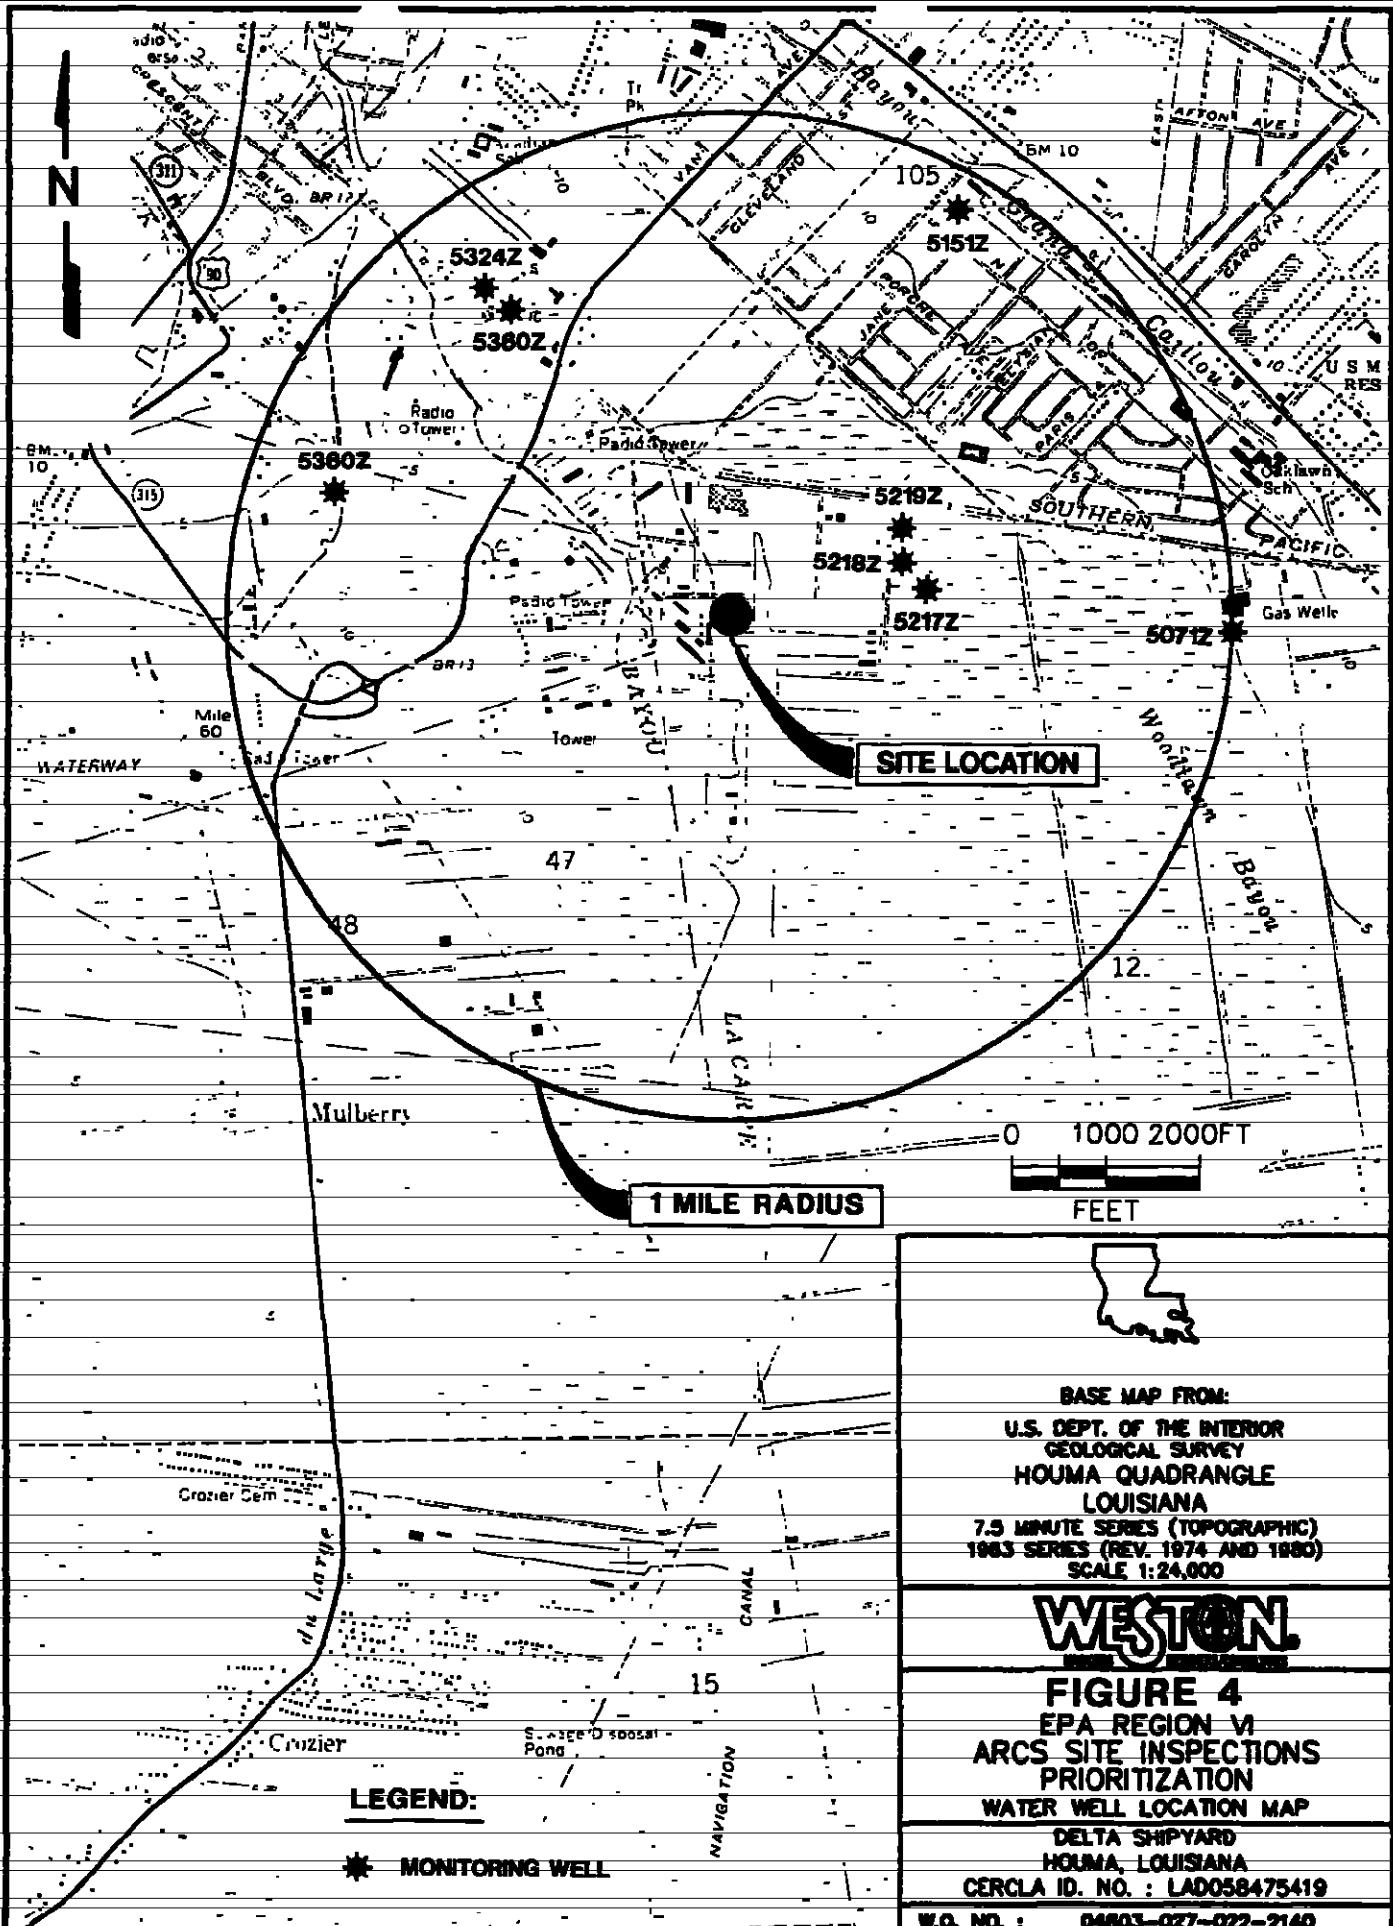
WESTON used file information from EPA VI and contacted the Louisiana Department of Transportation (LDOT) for information on water wells within a 1-mile radius of the site. LDOT files indicate several monitoring wells and 1 rig supply well are located within a 1-mile radius of the site. The rig supply well is plugged and abandoned. The closest wells are three monitoring wells located 2,000 feet to the northeast of the site. They are owned by Torch Energy and are completed in the Mississippi River Alluvial Aquifer Confining Unit. They were drilled in 1990 and range from 7 to 10 feet deep. A Water Well Location Map is provided in Attachment 1 as Figure 4.

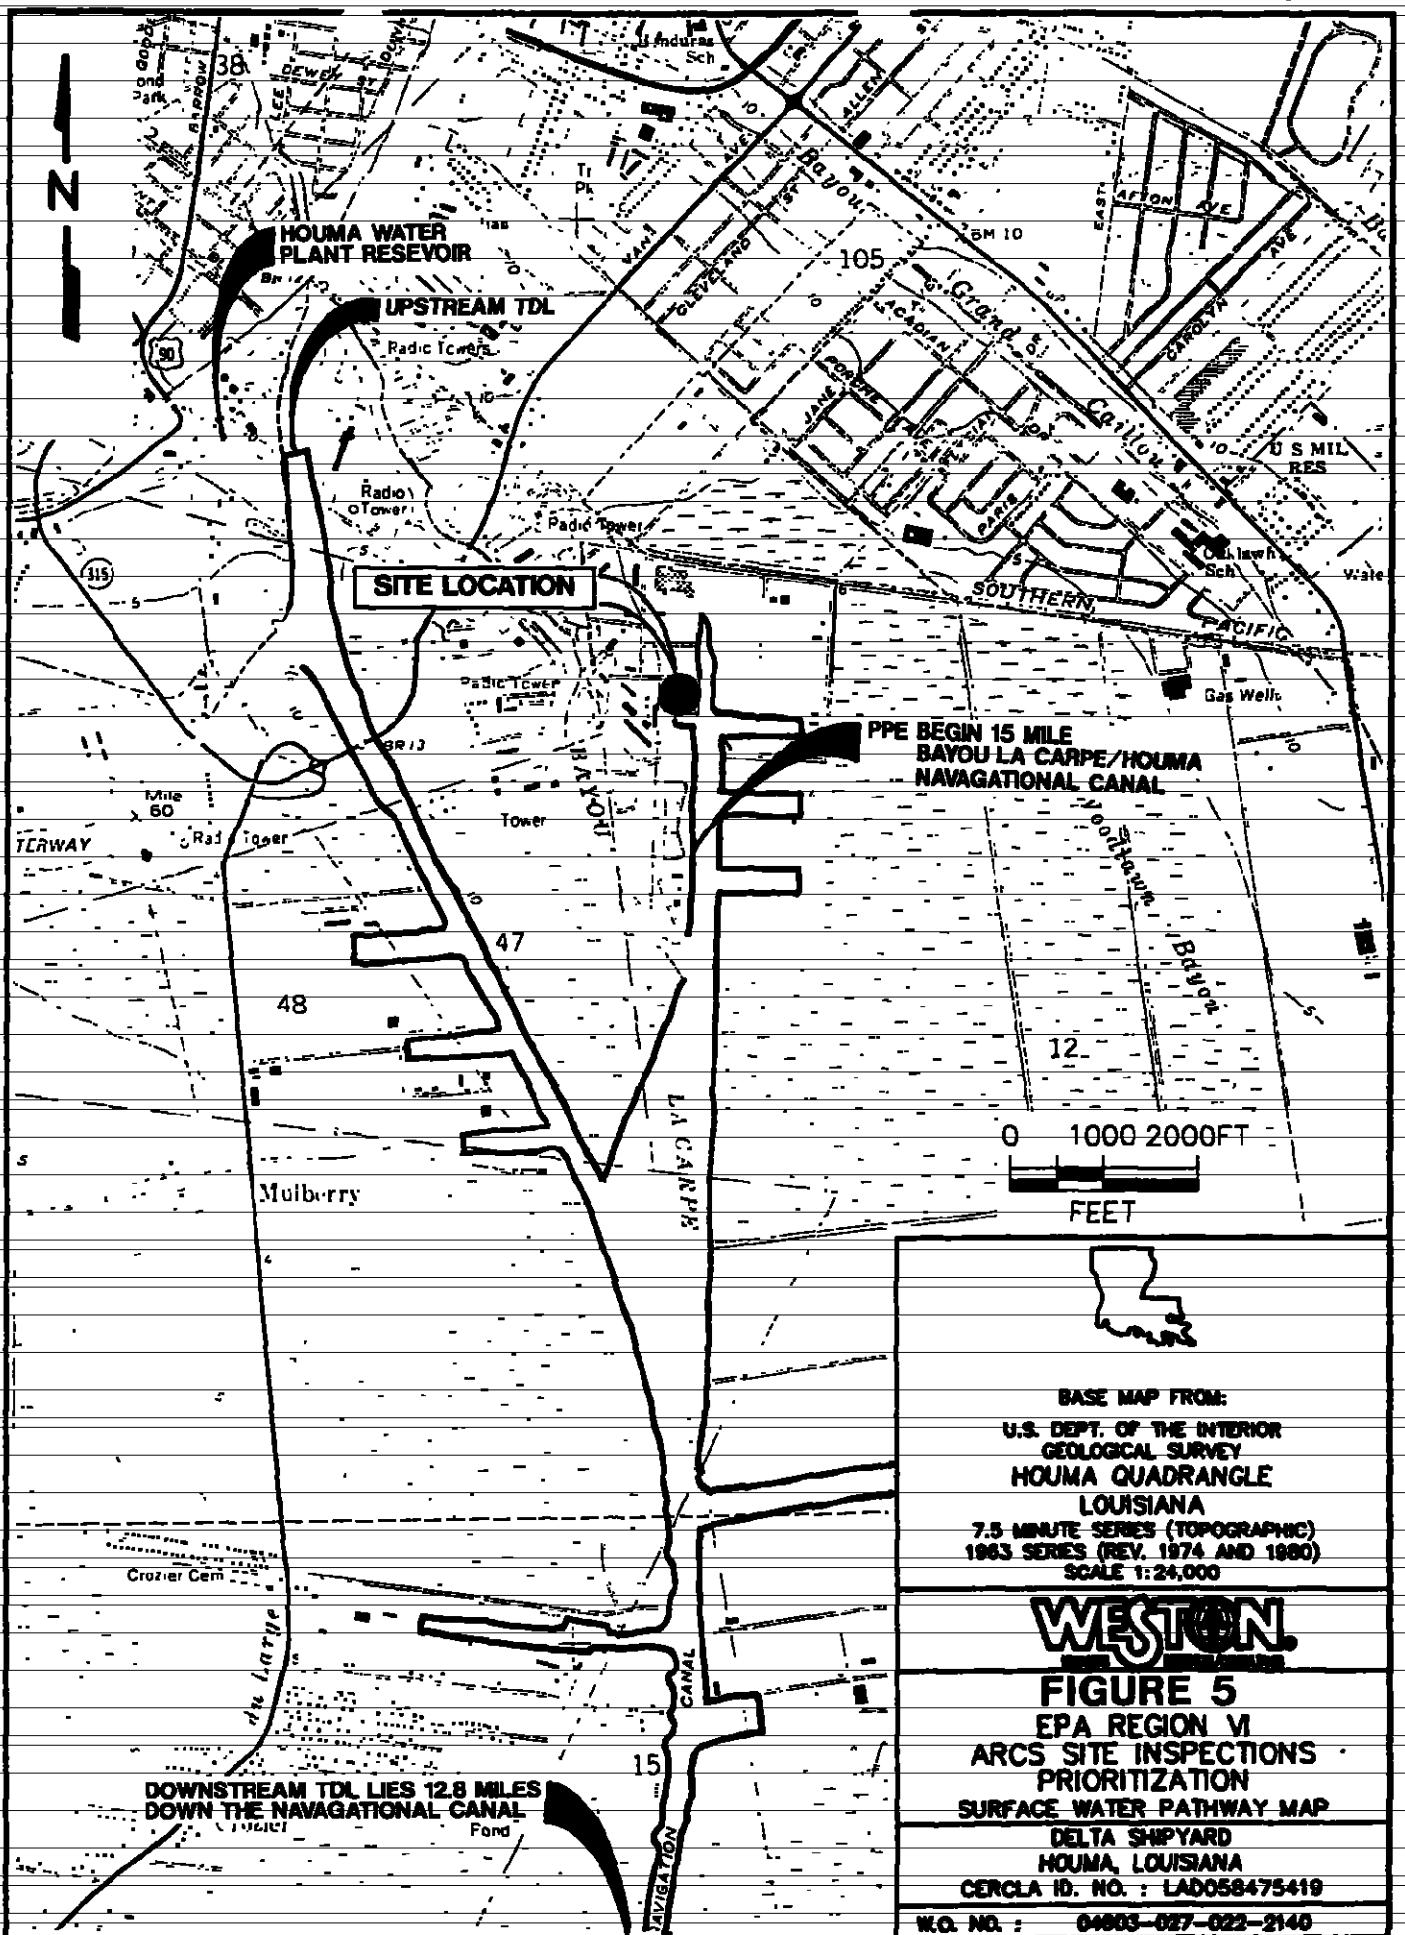
Surface water runoff draining from the site flows into Bayou La Carpe. Bayou La Carpe enters the Houma Navigational Canal just south of the site. According to the Houma, Louisiana, 7.5-minute wetlands map, the Houma Navigational Canal is bordered by extensive wetland areas. A Surface Water Pathway Map is provided in Attachment 1 as Figure 5.

The laboratory analytical results for sediment samples SED-4 through SED-7 collected during the SIP can be used to characterize the potential for contaminant migration in the surface water pathway. A drainage ditch runs along the west and south ends of Pits 1 through 3. An overflow pipe on Pit 2 drains rainwater from the pit into the ditch. Surface water draining from the pits follows the ditch approximately 0.3 mile until reaching the probable point of entry (PPE) at Bayou La Carpe. Bayou La Carpe flows approximately 4,000 feet south until reaching the Houma Navigational Canal. The Houma Navigational Canal is tidally influenced. Due to the tidal influence, two TDLs are assigned to the site, TDL-1 and TDL-2. TDL-1 is located approximately 2.55 miles upstream of the PPE at the water plant, the farthest point where saltwater intrusion has been documented. TDL-2 is located 15 miles downstream in the Houma Navigational Canal.

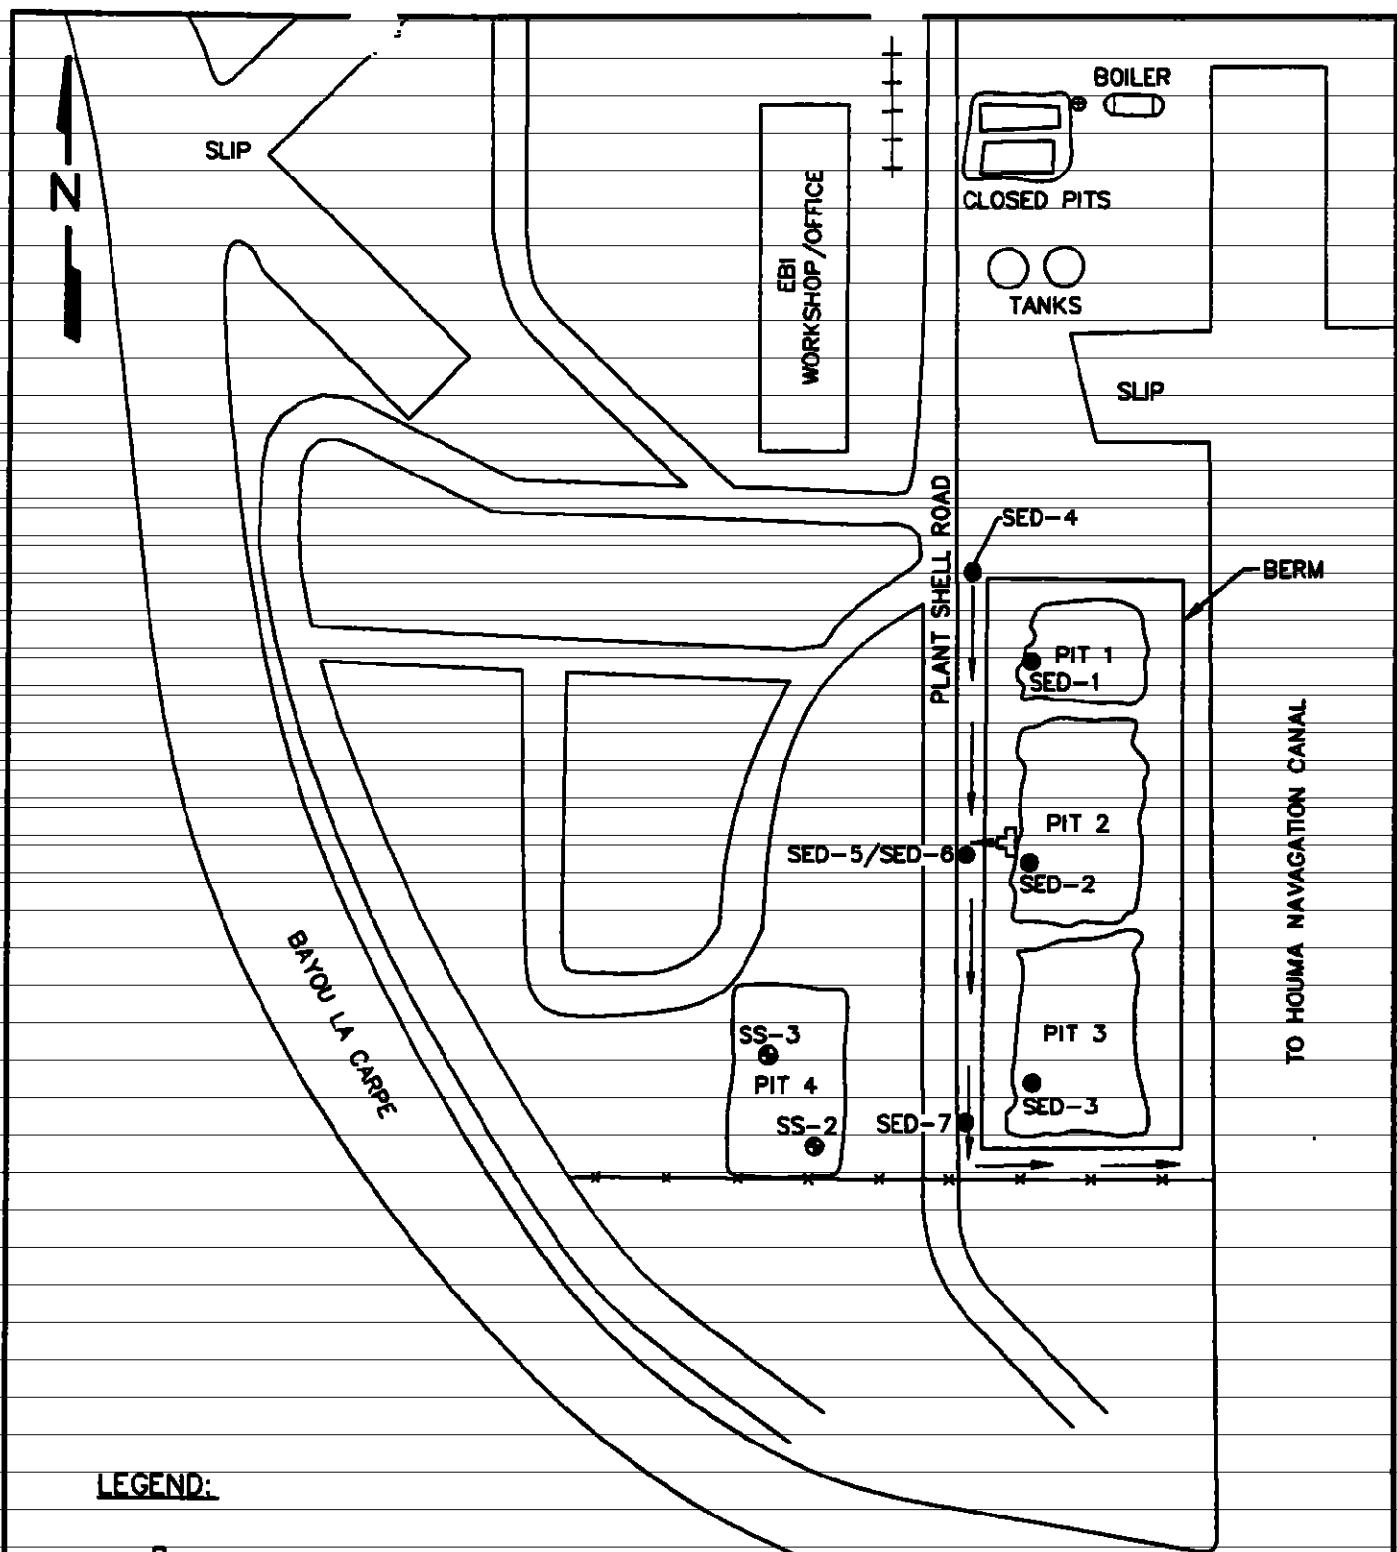
WESTON
ENVIRONMENTAL SERVICES
FIGURE 6
EPA REGION VI
ARCS SITE INSPECTIONS
PRIORITIZATION
SAMPLE LOCATION MAP
DELTA SHIPYARD
HOUMA, LOUISIANA
CERCLA ID. NO. : LADO58475419

WESTON collected seven sediment samples (SED-1 through SED-7) and three soil samples (SS-1 through SS-3) in an effort to document the presence and migration of hazardous substances associated with the potential hazardous waste source areas (HWSAs) at the site. Sample locations are shown in Attachment 1 as Figure 6. SIP soil/sediment sample locations, descriptions, and rationales are summarized in Attachment 3 as Table 1.

SS-1 IS TAKEN OFFSITE AS A BACKGROUND SAMPLE.
